# INNOVATE

## TROUBLESHOOTING GUIDE

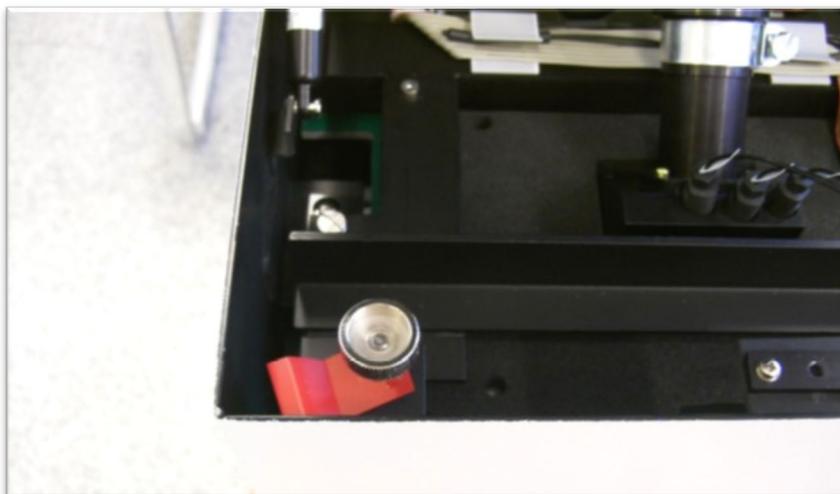
**Step 4:** Perform a volume check to ensure that the liquid is being injected correctly.

**Step 5:** Perform a few **wash** cycles to confirm alignment

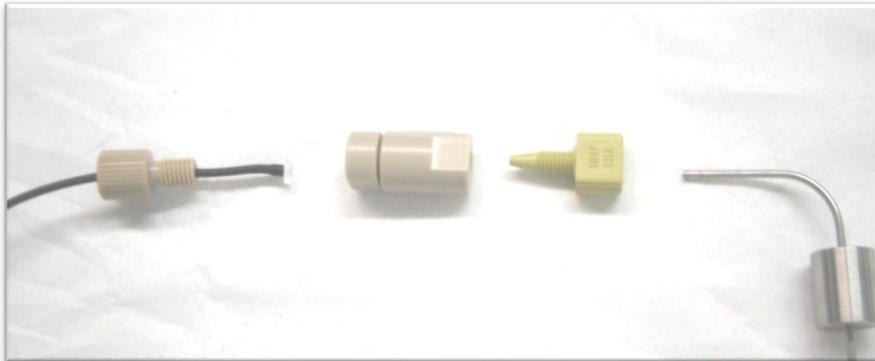
**Step 1:** Unscrew the filter assembly

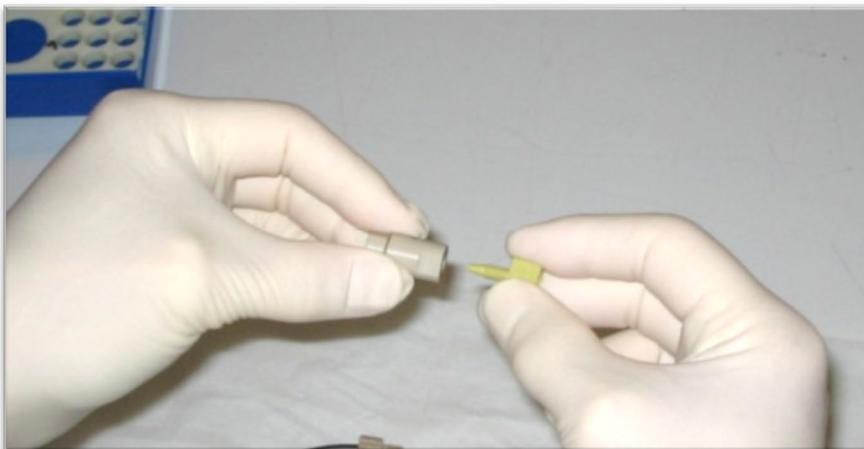
**Step 3:** Screw the colored steel connector into the new, unclogged in-line filter **until finger tight**

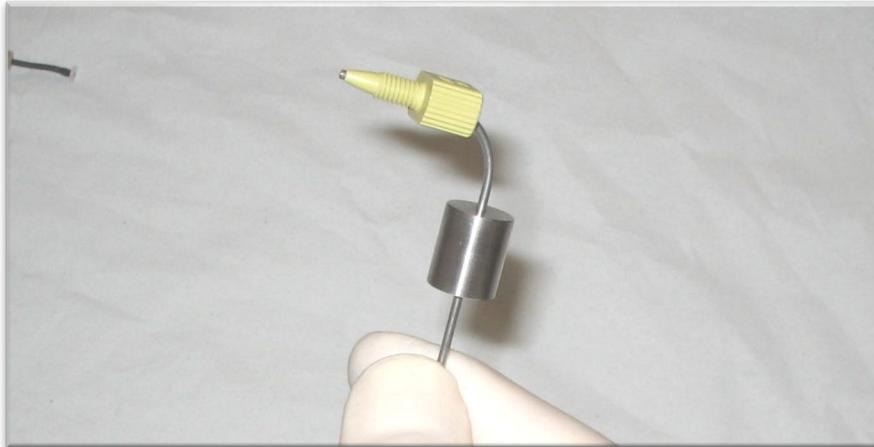
**Step 4:** Unscrew colored steel connector from in-line filter and place on the steel end as shown. Connector must stay fixed on the steel end

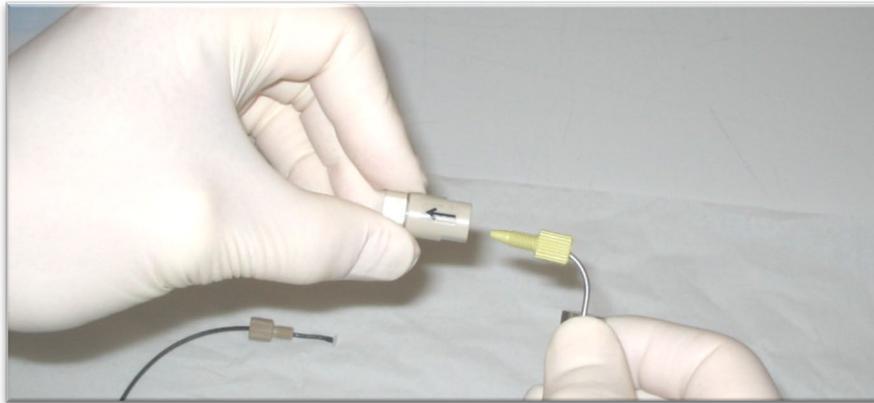
**Step 5:** Screw the new in-line filter onto the colored steel connector by holding the steel connection stationary, while turning the in-line filter until tight.

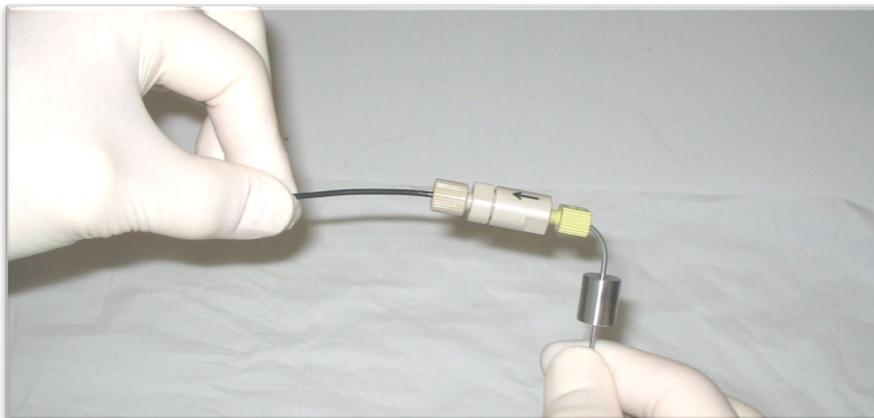
**Step 6:** Place tubing end into filter end. Screw tubing connector into in-line filter
